Mapping of Road Pavement Failure along Eyenkorin– Ogbomoso Road using Geographical Information System (GIS) Approach

Mapping of Road Pavement Failure along Eyenkorin–Ogbomoso Road using Geographical Information System (GIS) Approach

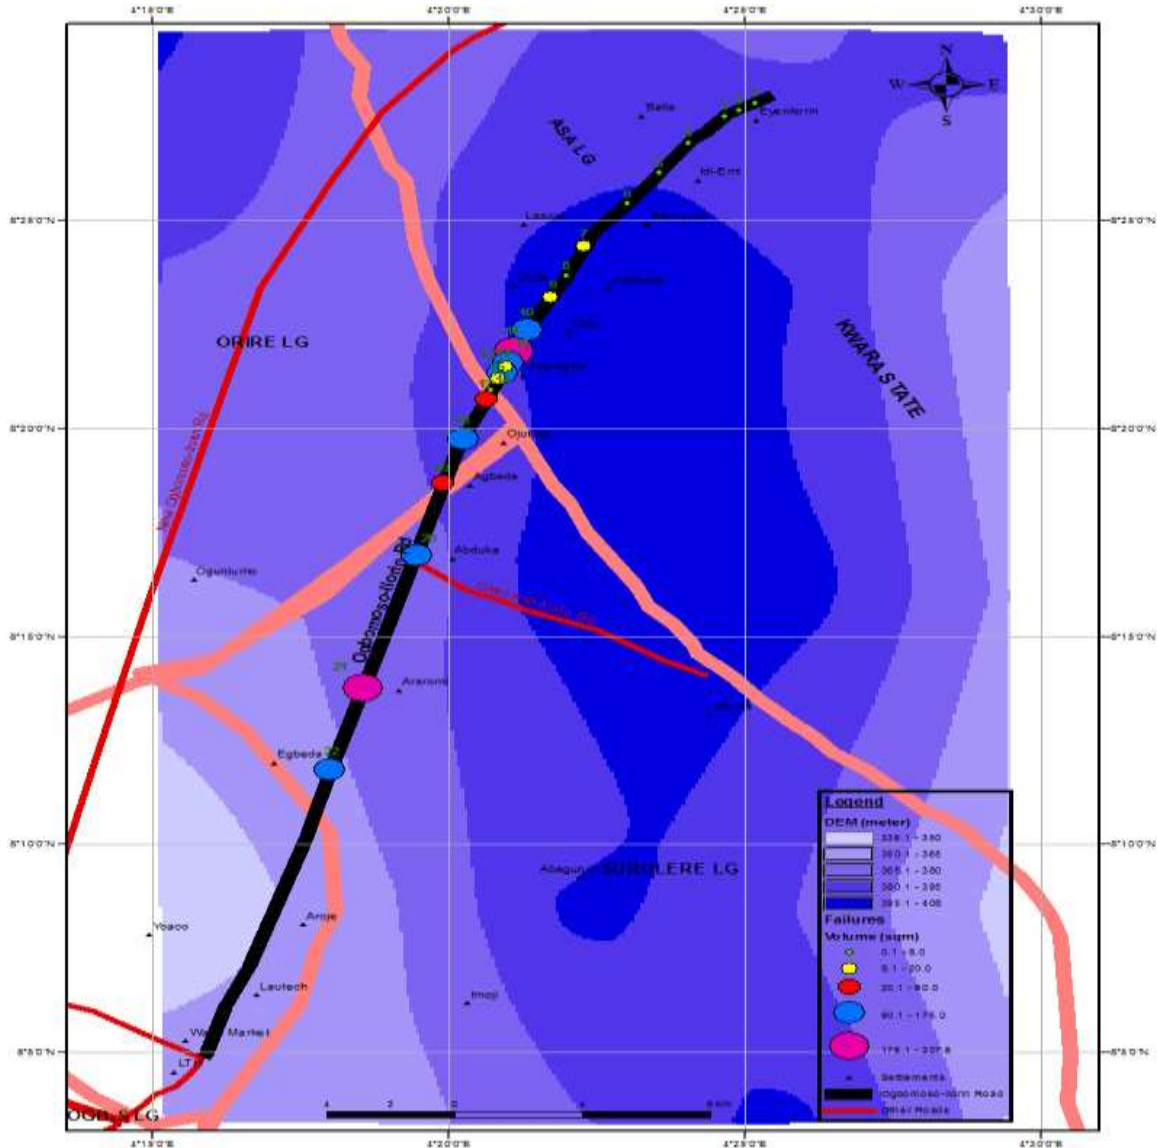
Figure 3: Elevation Map of Eyekorin-Ogbomosho Road in Meter
 Source: ESRI ArcGIS, 2010 Version
