Flooding Information System: A Case Study of Asa River, Ilorin, Kwara State, Nigeria

Awoloye Sunday Raphael

Department of Surveying and Geoinformatics
Institute of Environmental Studies, Kwara State Polytechnic, Ilorin

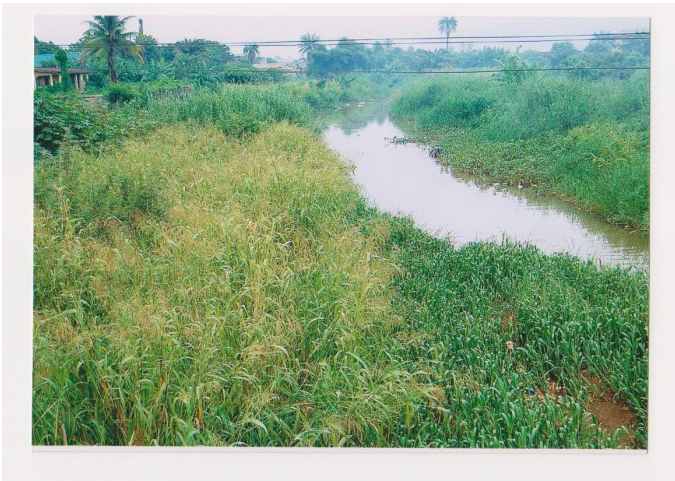
Figure 1:- Narrowed Channel as a Result of Vegetation cover Source (Author).

to produce an up-to-date information about flooding, GIS is the best tool to be applied. (GIS) Geographic information system is a system for integration of spatially referenced data for decision making in a problem solving environment (Kufoniyi, 1998). Dumping of refuse in the river especially during dry season may lead to blockage of river channel which may eventually introduction of easte disposal system by the Kwara state government, river Asa had been the sources of waste disposal in florin metropolis which led to the blockage of its channel and consequently over flow of its bank at different time. Also vegetation has almost blocked the channel of the river and invariably limit the channel of the river and reduces the speed at which the river flows. An example is shown in figure 1

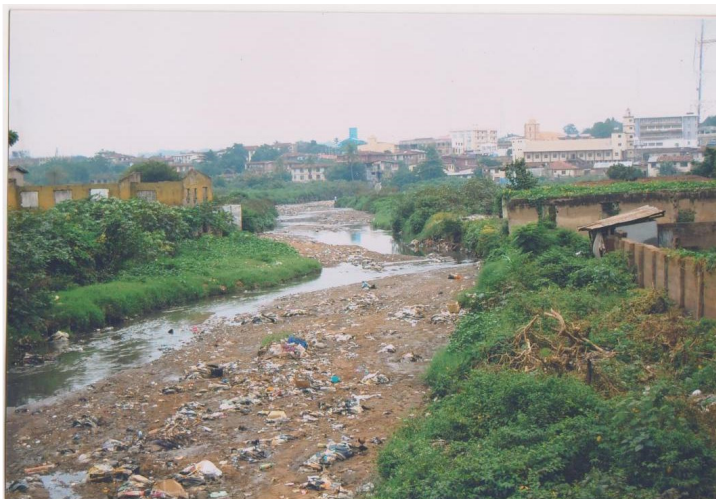
Figure 2: Dilapidated buildings and Refuse Dumped on the River Channel. Source (Author)

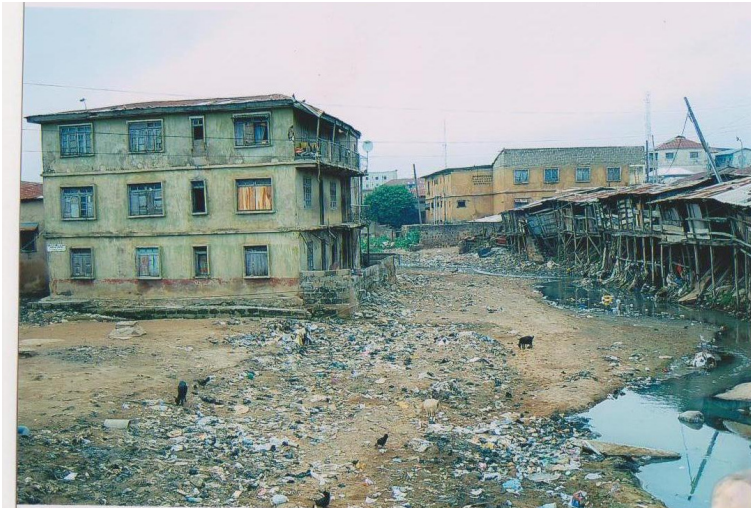
Figure 3:- Abandoned Building on Floodplain. Source (Author)
