## MORPHOMETRY AND MORPHOLOGY OF GULLIES IN NASARAWA STATE, NIGERIA

### ABSTRACT

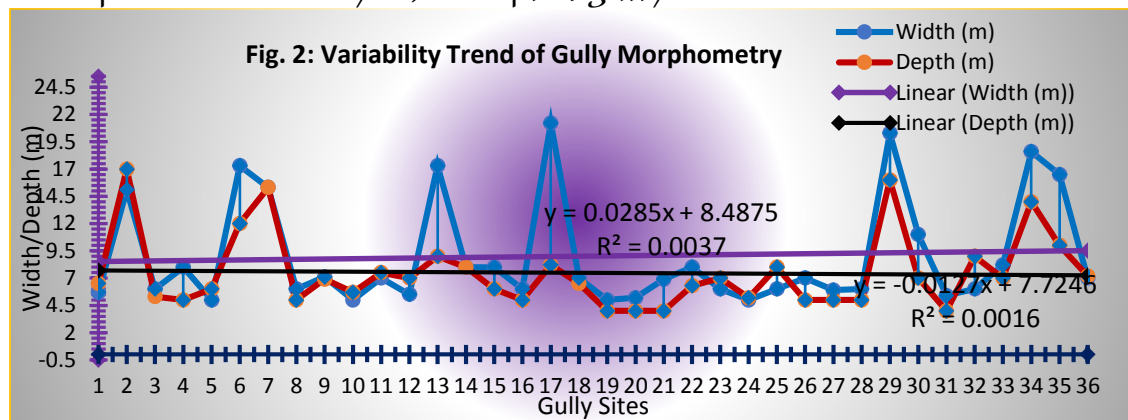
From the information depicted in the Figure 2, it can be observed that there no significant variation between gully width and gully in the study area. However, the most notable variation between the width of gully erosion and the depth of gully erosion experienced in the study area was recorded in site 6, 13, 17, 29, 34, and 35. Furthermore, the coefficient of variation ( $R^2$ ) shows that the variability of gully Morphometry in the study area in terms of the gully width in the entire sampled site was 4%. The implication here is that the width of gully Morphometry in Nasarawa State is almost constant and varies at only 4%. Similarly, the coefficient of variation in respect to gully depth Morphometry was 2%. Hence, the implication here is that the depth of gully Morphometry in the study area is almost constant as indicated by the almost straight linear trend line, and varies at only 2%.

When we talk of variability (also called spread or dispersion) we as simply referring to how spread out a set of data is. Variability gives you a way to describe how much data sets vary and allows you to use statistics to compare your data to other sets of data. This section looks at the variability of gully morphometric properties in the study area. The severity of gully erosion in the study area is depicted by the trend chart in Figure 2, and Figure 3 which shows the variability of gully Morphometry in the study area. The variability trend depicted in Figure 2 shows the degree of variability in gully width and gully depth, hence, the severity of gully in the study area, in respect to the thirty-six sampled gully sites.

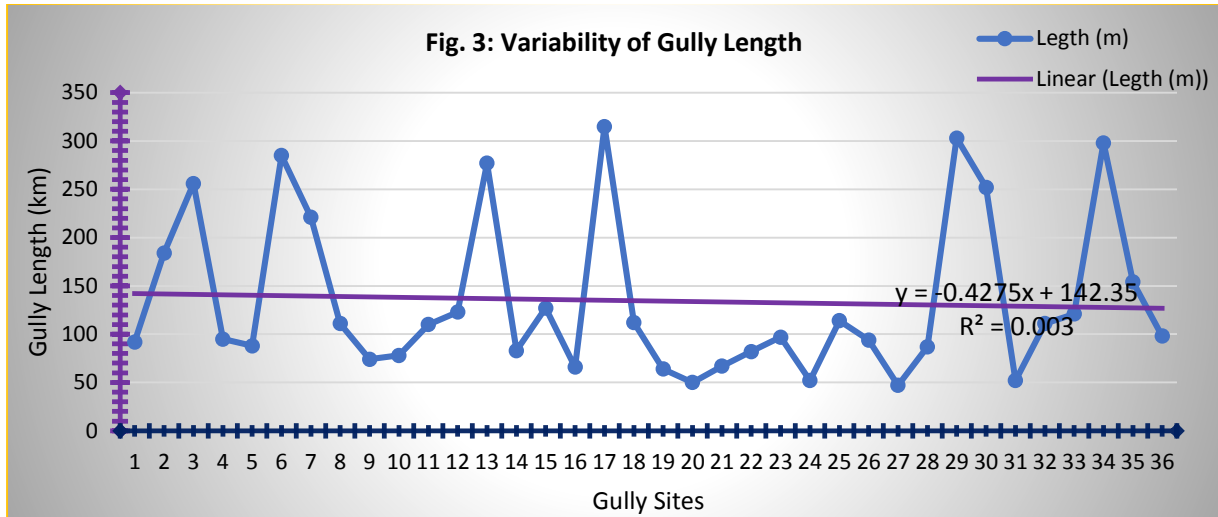
Variability of gully Morphometry in respect to gully length in the study area was also analysed and depicted in Figure 3. From the trend chart, it can be observed that almost no site recorded the same measure in length of gully erosion in the thirty-six sampled gully sites in the area of study. However, it is important to point out that there was no significant variation in gully length in the area of study, as depicted by the almost sight linear trend line. The linear equation in the shows the coefficient of variation of gully length in the sample sites at 3%.

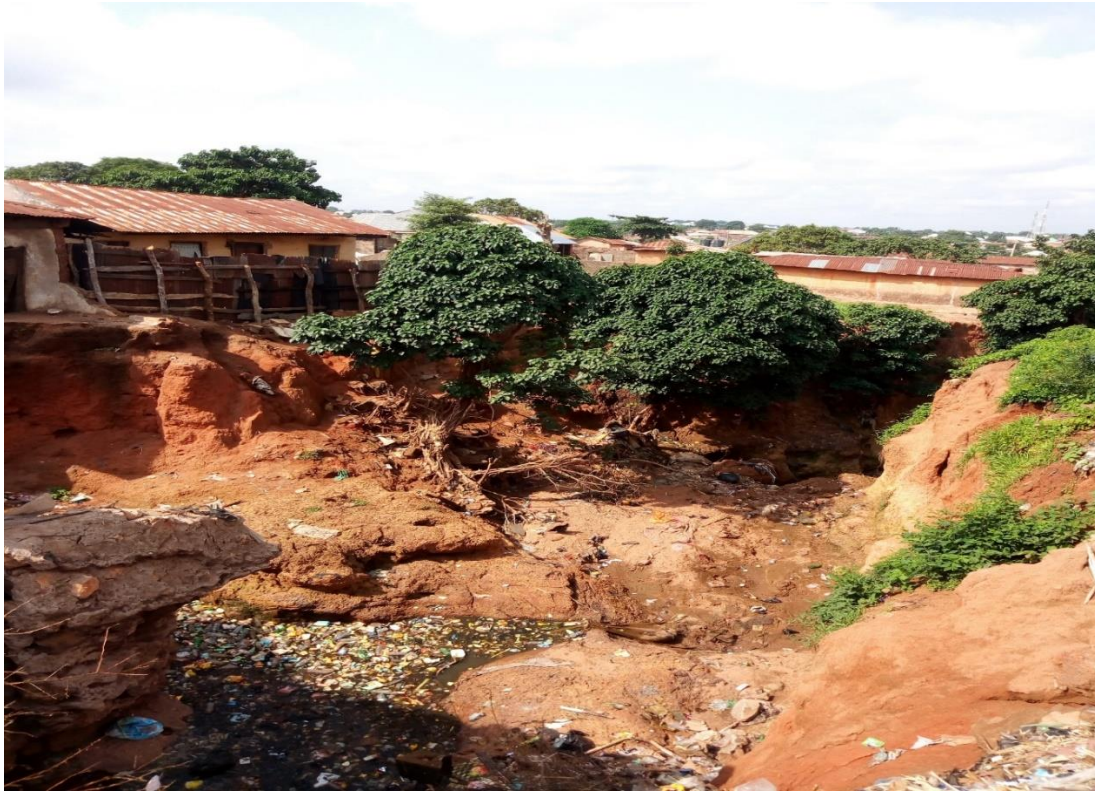
*Plate 1: A typical gully cross-section in Kilema, Lafia LGA  
Source: Field work.*

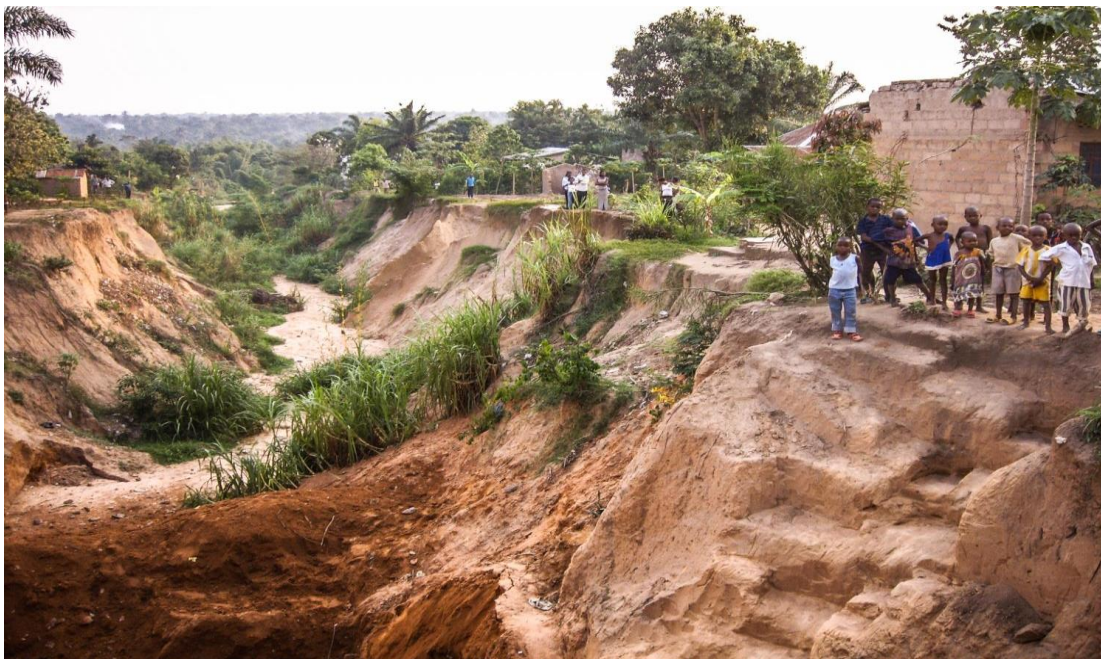
*Plate 3: Linear shaped gully in Kwandere site, Lafia, LGA  
Source: Field work.*

in the study area. In determining the various class of gullies in the study area, the methods of Ireland, *et al.* (1996) and Leopold and Miller (1956) were employed. From the results presented in the Table 4.4, it can be observed that 44.4% of the gullies in the study area are discontinuous gullies, while 55.6% were continuous gullies. Discontinuous gullies are characterized by respectively low or gentler gradients and they are caused by local oversteeping of slopes due to aggravation. This method was applied by Heede (1974, 1970, and 1976), Cudason, (2005), and Blon (1966, 1970) in the north island of New Zealand. Mosley (1972), recorded in Bocco (1990) studied a discontinuous gully system in alluvial fills in the Colorado piedmont (USA). In this study, the characteristics of gully morphology were agent which operate frequently during heavy rain or strong winds. Gully system is said to be discontinuous when it reached its shape of maturity. Heede (1975) in an attempt to predict gully growth and guide consideration works combine the concept of discontinuity with that of stages of cyclic gully development. Based on field observation on the flanks of the Rocky Mountains (USA), he noted that discontinuous gullies represent youthful stages in gully development. Continuous gullies. These gullies in the study are at their 5% and above development. The stage of gully development consists of the development of the channel cut through the top soil and upper 'B' horizon. The early stage of a continuous gully, characterized by several knick points on the channel both on, can be termed the 'early mature' of development (Bocco, 1991).
