IDENTIFICATION AND CHARACTERISTICS OF GULLY EROSION IN NORTH CENTRAL NIGERIA: CASE STUDY OF NASARAWA STATE

¹Anzaku, I. M., ²Ishaya, K. I. & ³Ogah, A. T.

Department of Geography, Nasarawa State University, Keffi, Nigeria

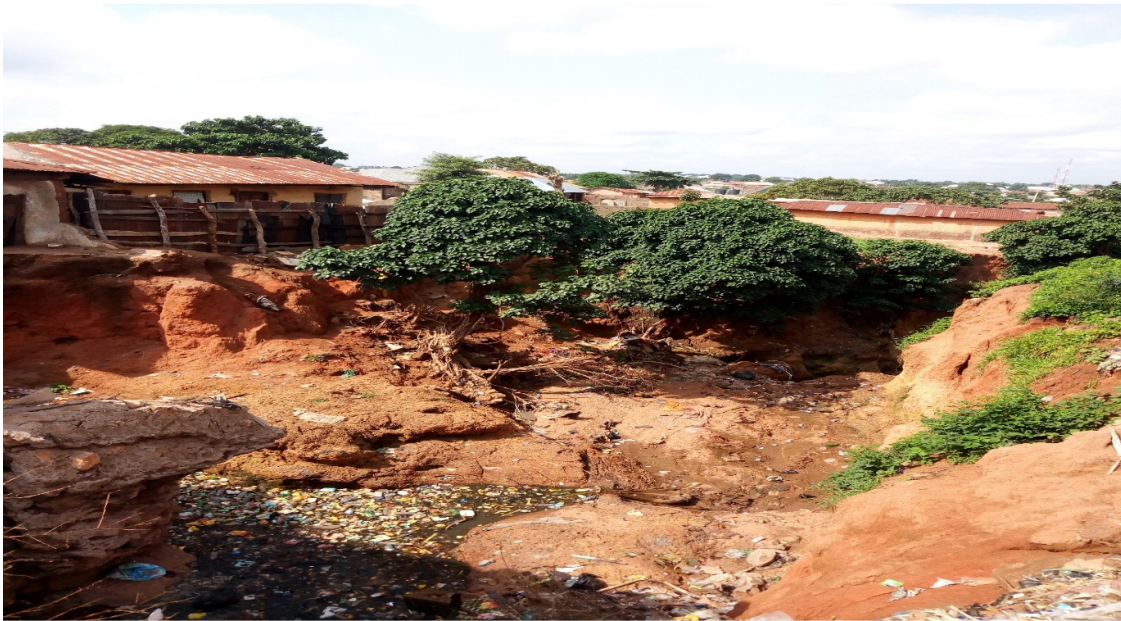
From the data presented in Table 1 and 2, it can be observed that in Lafia Local Government Area, Kilema site recorded the high gully erosion, with gullies in this site covering an area of 667.8m², with length of 3154m and a width of 21.2m. The depth of gully in this site was recorded at 8.2m. In terms of cross section, gullies found in this site were U-shaped gullies, and large in terms of magnitude. The particle size distribution for the underlined gully site were; sand 91.2%, silt 3.4% and clay 5.4%. Gully in this site are typically characterized by terrain-step slope.

Plate 1: A typical gully cross-section in Kilema, Lafia LGA
Source: Field work.

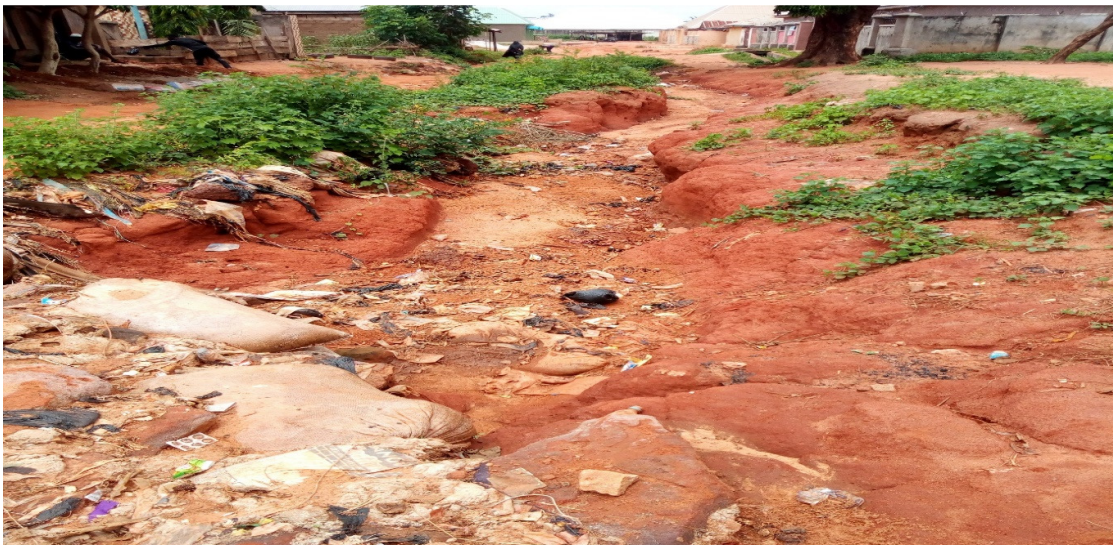
Plate 2: A typical gully cross-section in Kwandere, Lafia LGA
Source: Field work.

In Kwandere site, the gully size in the area are small gully with a length of 112m, covering an area of 78.4m², with a width of 7m and depth of 6.5m. The cross section of the underline gully is V-shaped, with particle distribution of sand 91.2%, silt of 3.4% and clay size of 5.4%. Akunza site on the other hand has a particle distribution size of sand 84.2%, silt 5.4% and clay 10.4%. The

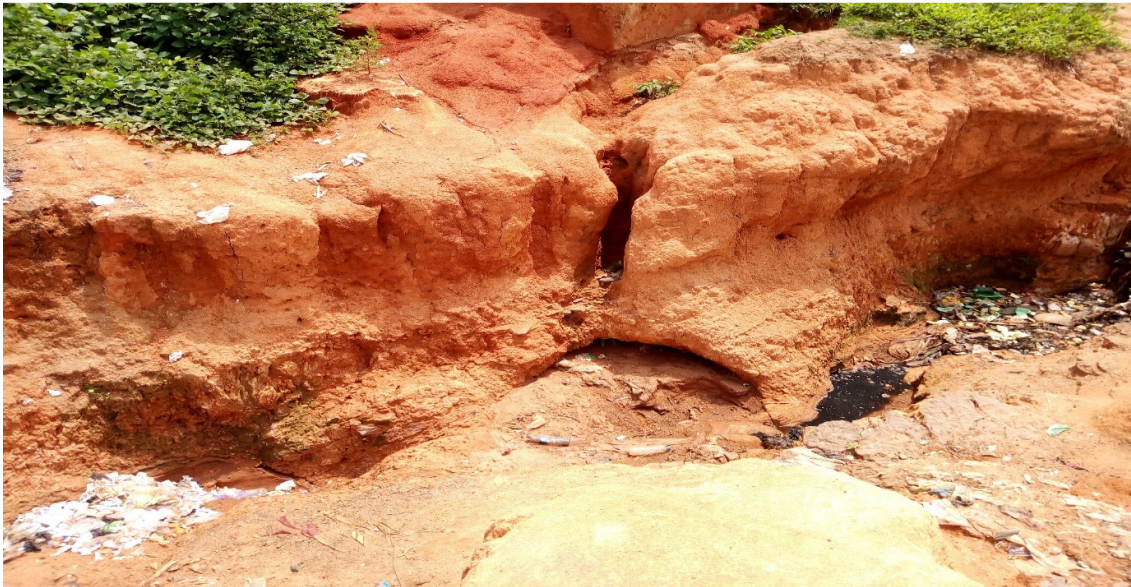
cross section of the underline gully site is U-shaped, while gully sizes are very small gully. In the same vein, the geometric characteristic of Akunza site has a depth of 6m, width of 5m, covering an area of 44.0m² with a length of 88m. Adogi site was characterized by large gully size, with a length of 256m, covering an area of 153.6m², with a depth of 5.3m and a width of 6m. The particle size distribution in the underline gully site consist of; sand 90.2%, silt 3.4% and clay 6.4%, while the cross-section of the gully site of the area of study is V and U-shaped. In Gundu site of the study area the cross-section of gully is U-shaped, with particle size distribution of clay 9.4%, silt 3.4% and sand 87.2%. In terms of size, the gully size of Gandu site is a small gully, covering an area of 676.5m², with a depth of 7m and a width of 5.5m, while the length of the gully site is 123m.

Plate 3: A typical gully cross-section in Adogi, Lafia LGA
Source: Field work.

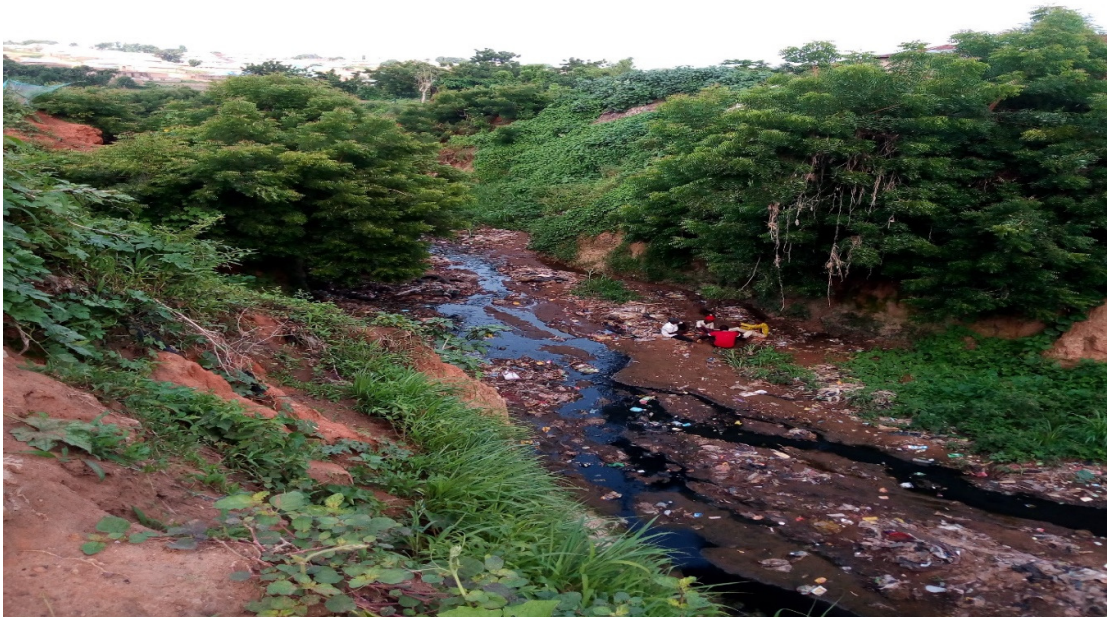
In Tudun-Allu site of the study area, the general characteristics of gully are not far fetched from the above discussed characteristics. However, the gully size of this site is a medium sized gully, covering an area of 277.2m^2 , with a depth of 7m , width of 11m and a depth of 252m . in terms of particle size distribution, Tudun-Allu site has the following underlying material; sand 90.2% , silt 3.4% and clay 6.4% . Danko site on the other hand had a particle size distribution of; sand 92.2% , silt 2.4% and clay 5.4% .

Plate 4: A typical gully cross-section in Tudun-Allu, Lafia LGA
Source: Field work.

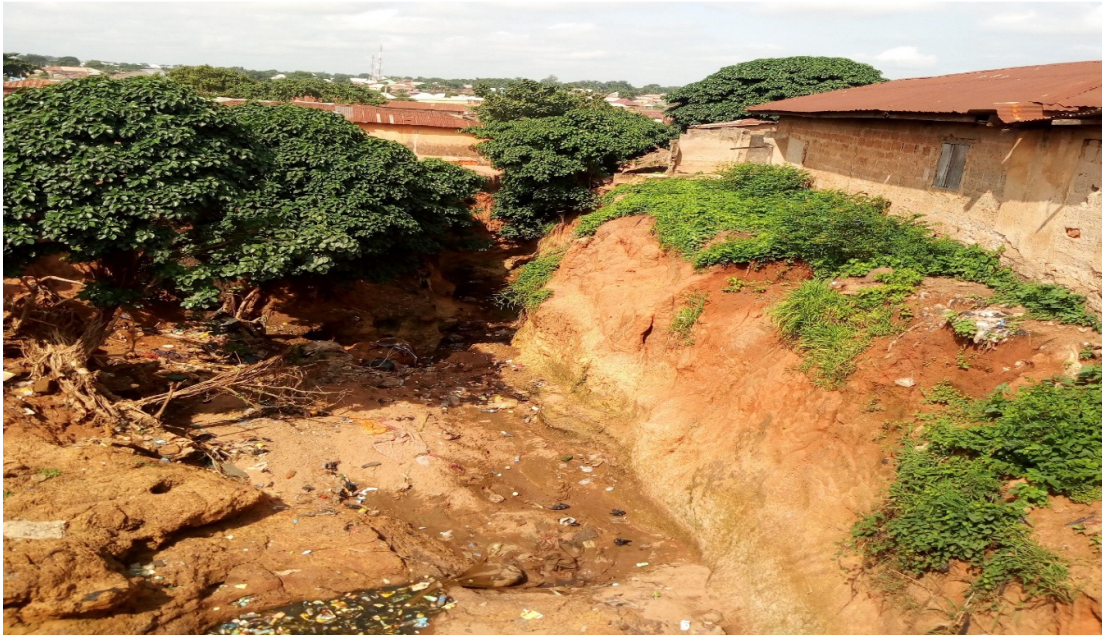
Plate 5: A typical gully cross-section in Gimare, Lafia LGA

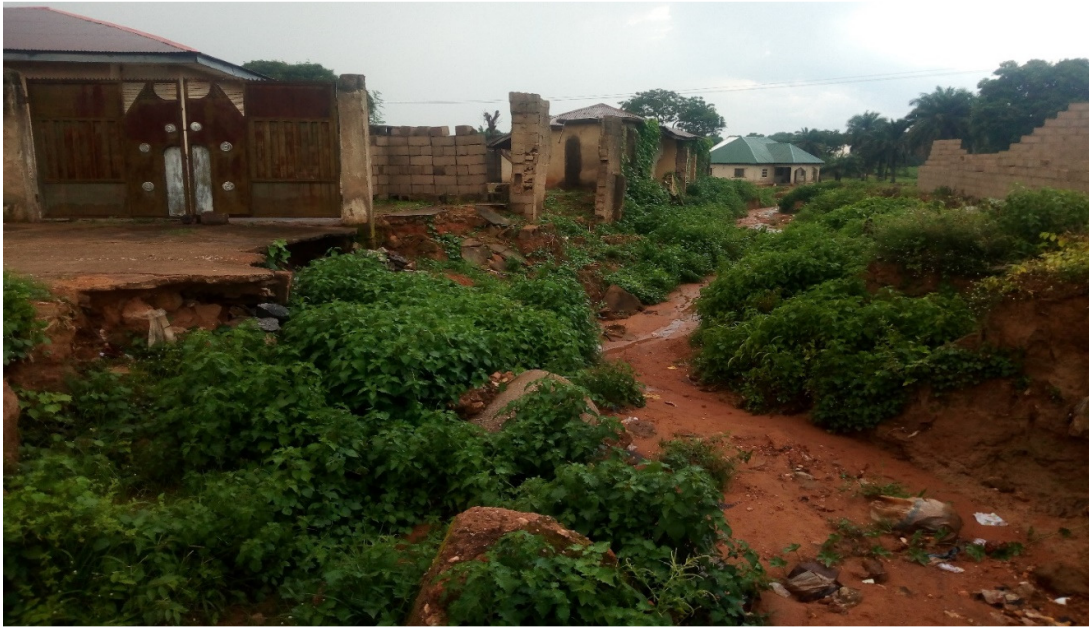
Gullies found in Wamba Local Government Area are typically characterised by stream and dense vegetation. It can be observed from a critical look at the data presented in Table 4.1 and 4.1.1 that the sites that recorded the work gully are Traffic and Farinruwa sites. It is important to point out that these sites recorded the most destruction caused by gully erosion among the entire sampled sites in the study. In traffic, the effect of gully erosion result to the destruction on houses, while in Farinruwa, the effect was the destruction of Access Bridge in the area. In cross section of gullies in Traffic are U-shaped gully and large in magnitude. the gully in this site covered and area of 615.09m^2 with a length of 303m and a width of 20.3m, recording a depth of 16m. The distribution of particle in the underlined gully site include; sand 88.2%, silt 3.4% and clay 8.4%. In the same vein, the cross section of gully in Farinruwa are U-shaped gullies. Gully in this site recorded a length of 110m, a width of 7m, and a depth of 7.5m, covering an area of 77.0m^2 . In terms of particle size distribution, the underlined gully recorded sand at 84.0%, silt 5.4% and clay 12.6%.

Plate 6: A typical gully cross-section in Traffic, Wamba LGA
Source: Field work.

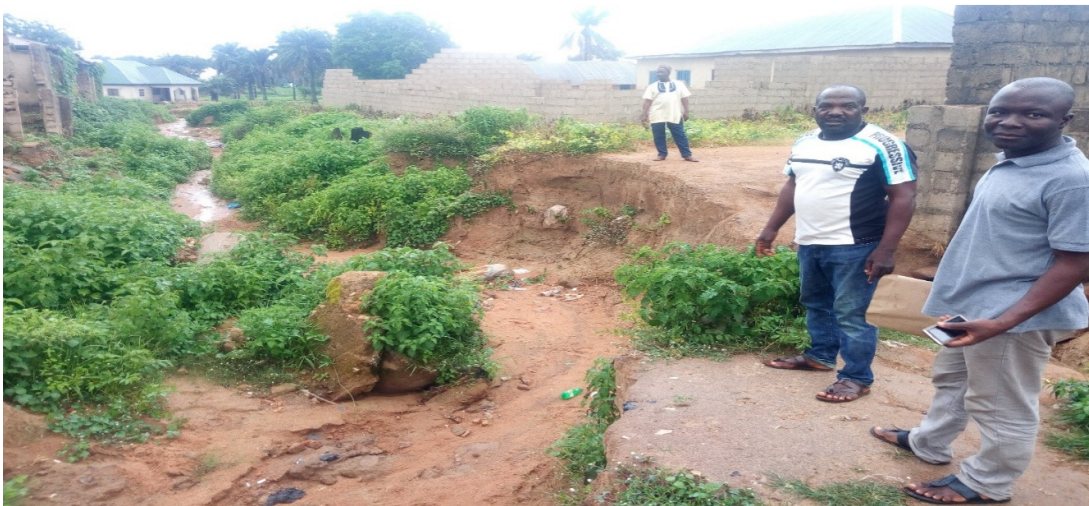
Plate 7: A typical gully cross-section in Traffic, Wamba LGA
Source: Field work.

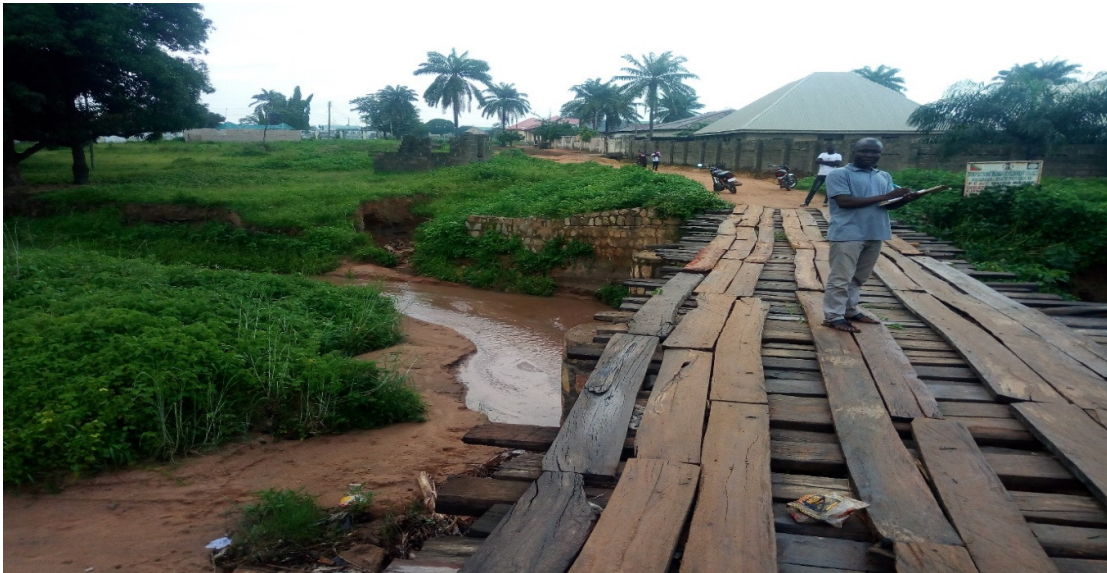
*Plate 8: A typical gully cross-section in Farinruwa, Wamba LGA
Source: Field work.*

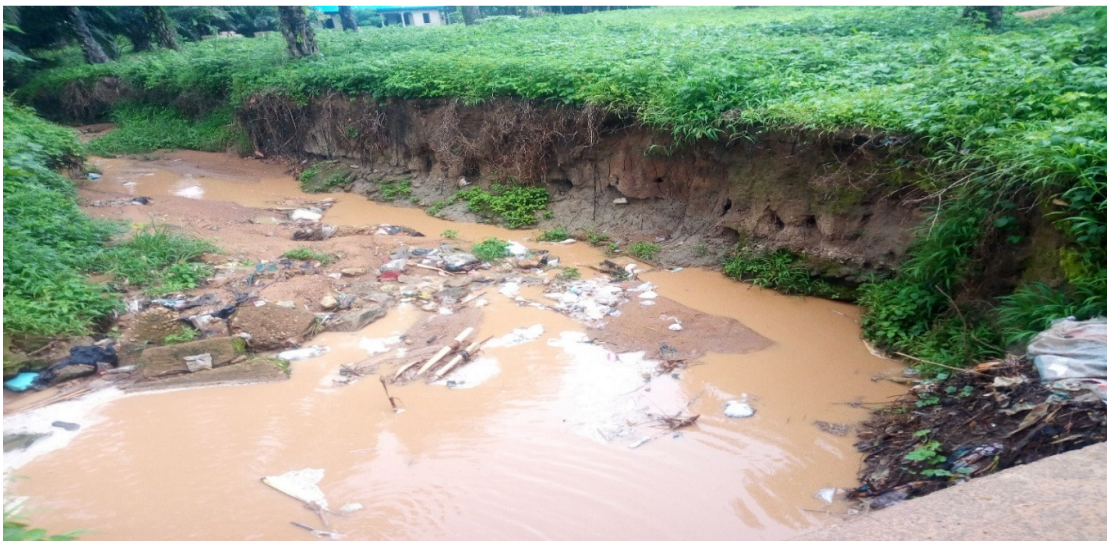
Gully found in Gangare Wawa was the most peculiar of all the gullies encountered in the study area. This is because the gully in this area was rectangular, and somewhat U and V-shaped in terms of cross section. The gully in the area covered an area of 479.21m² with a length of 277m, width of 17.2, and a depth of 9m. The magnitude of the gully is large, and characterised by stream and dense vegetation.

*Plate 9: A typical gully cross-section in Gangare Wawa, Wamba LGA
Source: Field work.*

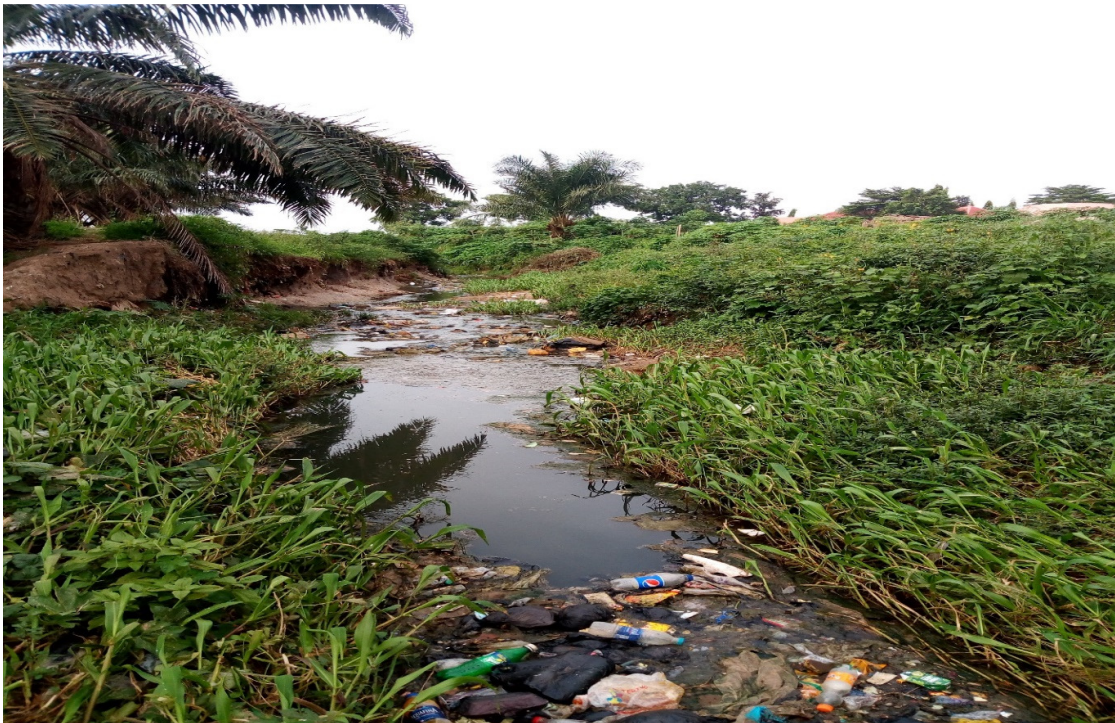
Gully sites in Karu Local Government Area are typically characterised by dense vegetation and streams. Unlike that of Lafia and Wamba Local government Area, gullies in Karu are less in terms of terrene steep slope. Large gullies were only found in Ado, with a coverage of length of 184m, and area of 277.84m², with a width of 15.1mand a depth of 17m. in terms of cross section, this gullies found in the site are U-shaped, with particle size properties of; clay 9.4%, sand 88.2% and silt, 4.4%.

Plate 10: A typical gully cross-section in Ado, Karu LGA

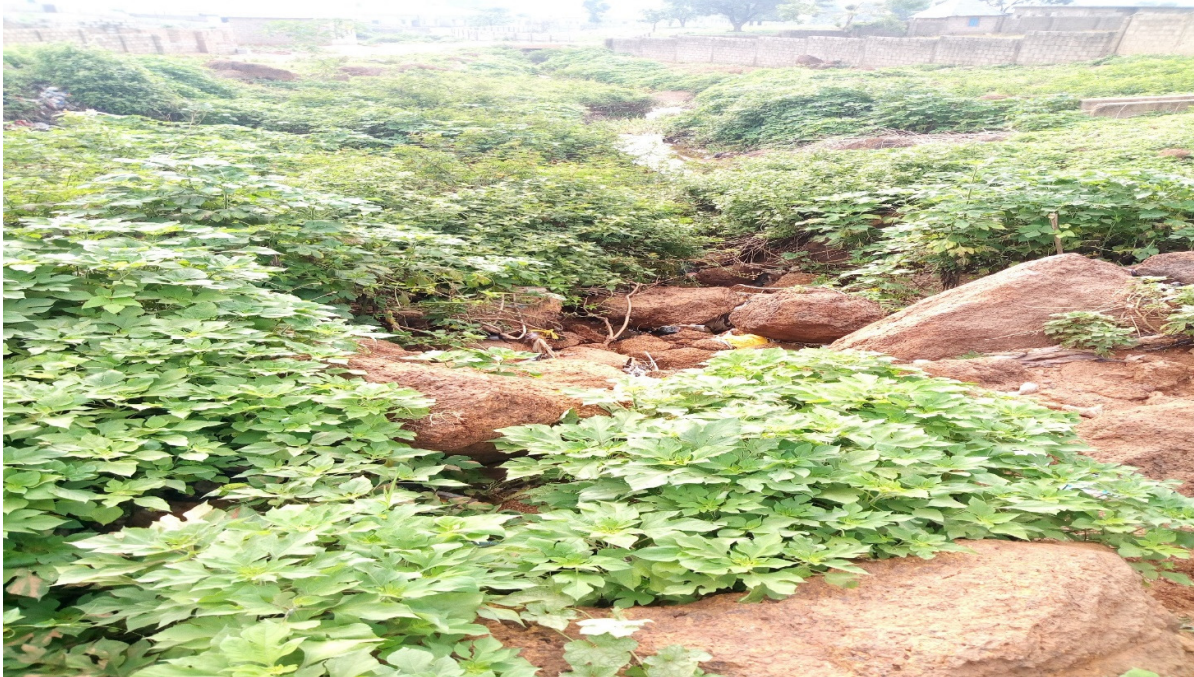
Gullies found in both Sabon Gari and One-man Village were both medium gullies, with a cross section of V and U-shape. in terms of particle size distribution, Sabon Gari recorded; clay 12.4%, silt 3.4% and sand 84.2%, while One-man Village recorded clay 27.4, silt 29.9% and sand 43%. Furthermore, gullies found in One-man Village covered and area of 68.4m², with a width of 114m, width of 6m and a depth of 8m. In the same vein, gullies found in Sabon Gari covered and area of 65.8m², with a depth of 5m, width of 6m and a length coverage of 94m.

*Plate II: A typical gully cross-section in Sabon Gari, Karu LGA
Source: Field work.*
